Manhole Inspection Summary

Manhole # S35Y1_021MH

Insp Date: **8/7/08 1:28 PM**

Location Address: **21 Potee St**

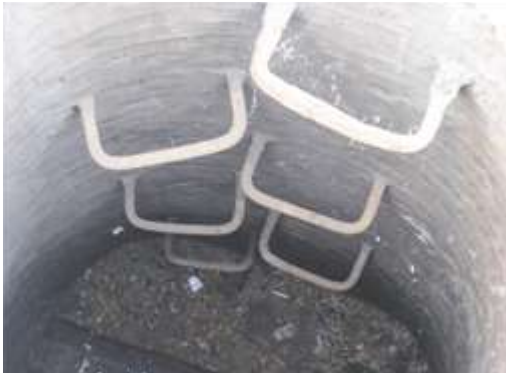
Steps Count: **10** Missing: **0** ☒ **Corroded**

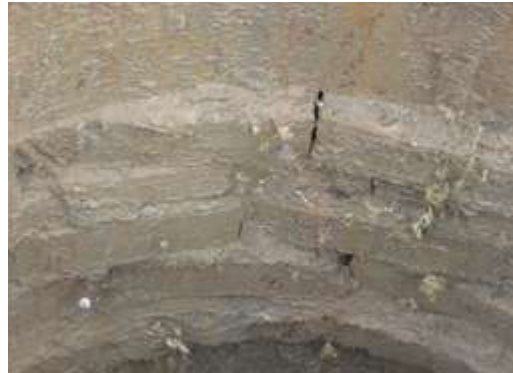
Defect 1

Cracked Chimney.

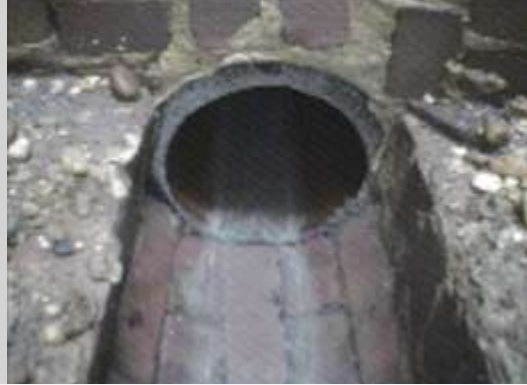
12 O'Clock Outflow

8 in. Circular Gravity Sewer
Pipe Out @ 12 O'Clock

Pipe Height: **30** (in.) Rod and Bar (Angled)
Pipe Material: **Clay** ☐ Pipe Lined
Invert Depth: **18.34** (ft.) Flow Characteristics: **Slow**
Deposits: ☒ None ☐ Mud ☐ Sludge ☐ Debris ☐ Grease
Silt Depth: (in.) Deposits Extent:
Infiltration: **None** Pipe Seal Cond: **Sound**

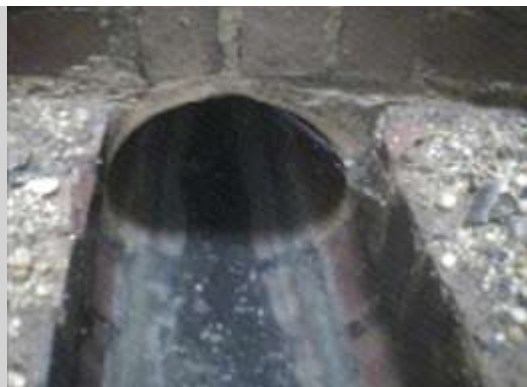
6 O'Clock Inflow

8 in. Circular Gravity Sewer
Pipe In @ 6 O'Clock

Pipe Height: **24** (in.) Rod and Bar (Angled)
Pipe Material: **Clay** ☐ Pipe Lined
Invert Depth: **18.20** (ft.) Flow Characteristics: **Slow**
Deposits: ☒ None ☐ Mud ☐ Sludge ☐ Debris ☐ Grease
Silt Depth: (in.) Deposits Extent:
Infiltration: **None** Pipe Seal Cond: **Sound**
